**COMBINED ASSESSMENT REPORT**

**GRAYSLAKE GELATIN COMPANY  
GRAYSLAKE, ILLINOIS**

**PREPARED BY:  
ILLINOIS ENVIRONMENTAL PROTECTION AGENCY  
BUREAU OF LAND  
FEDERAL SITE REMEDIATION SECTION  
OFFICE OF SITE EVALUATION**

**MAY 28, 2003**

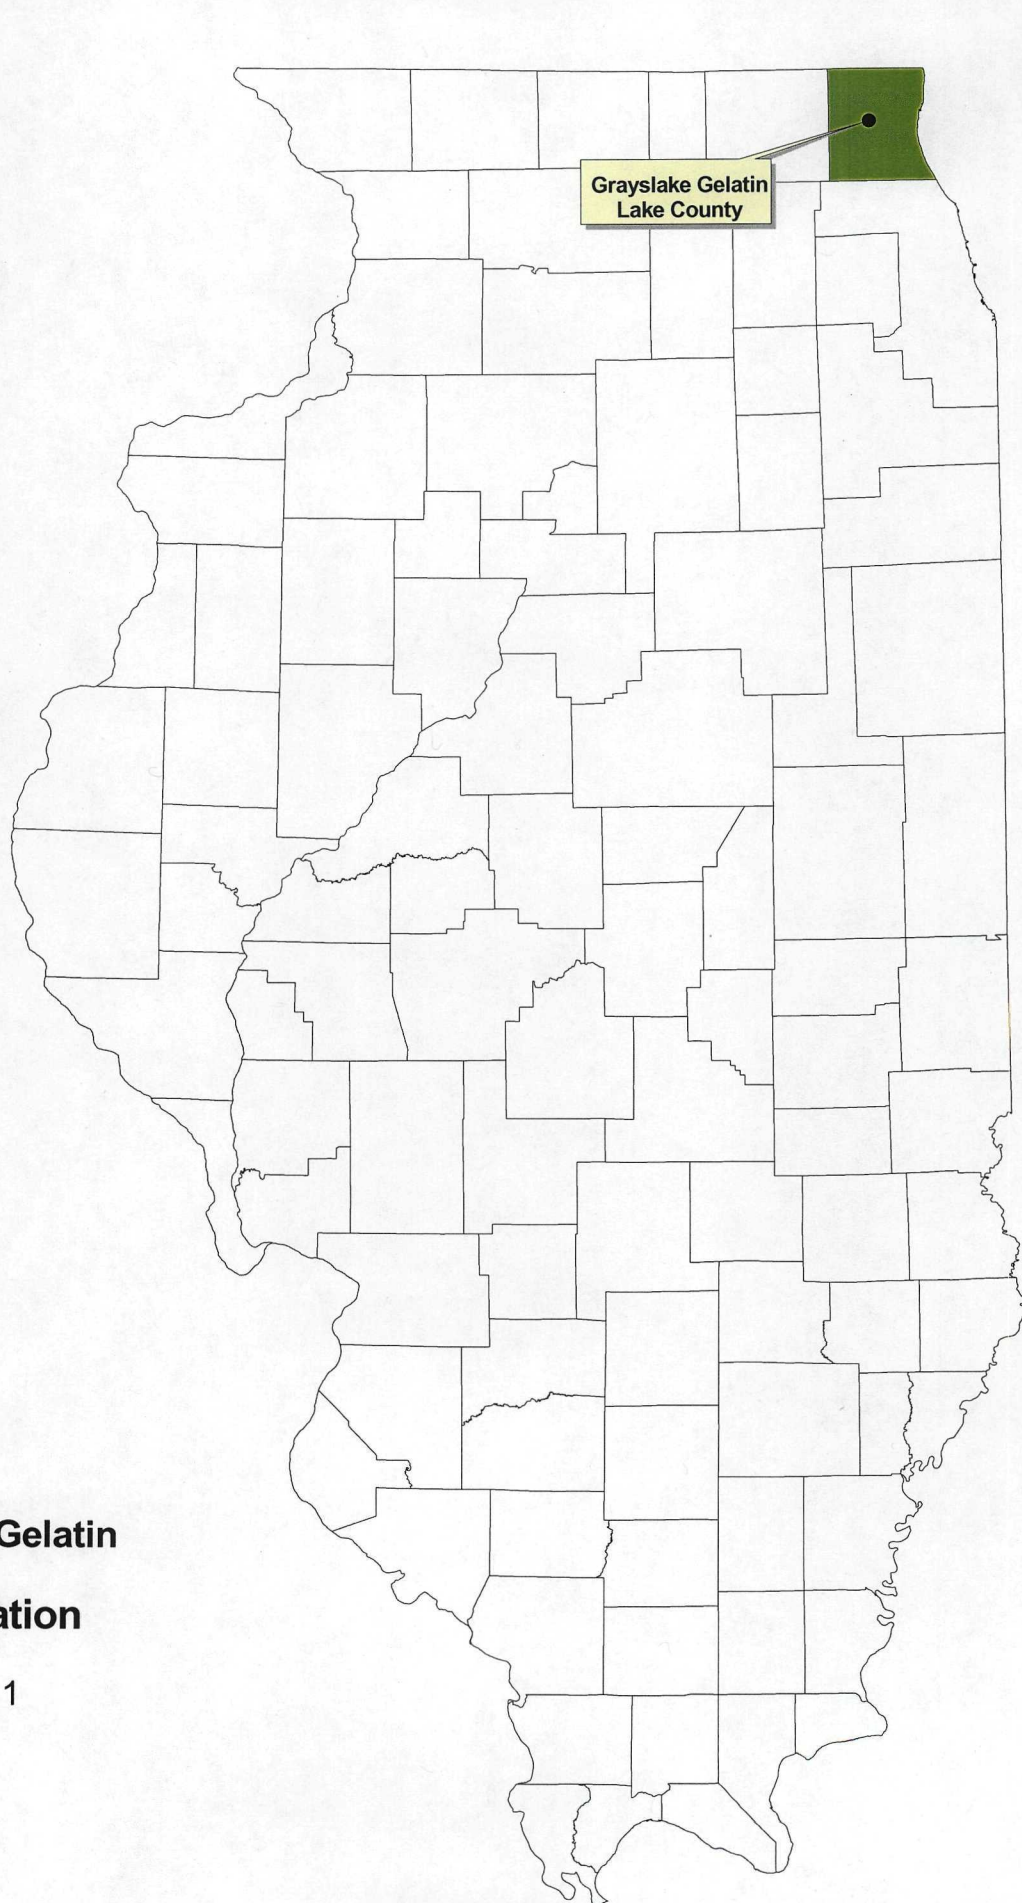
Figure 1

**Grayslake Gelatin**  
**Site Location**

Grayslake Gelatin Co. is located in east-central Grayslake, Illinois, one block north of the intersection of Railroad Avenue and Center Street in Avon Township, Lake County (see Figures 1, 2 & 3). Company operations consisted of manufacture of gelatin for industrial purposes. Currently the plant structures, former manufacturing and active areas occupy approximately 10.86 acres of land at the mentioned location. The company also, at some point in its history, had ownership of a large parcel of farm ground immediately adjacent to and east of the current property. During that time Grayslake Gelatin held a total of 65 acres. The site specific location of the current Grayslake Gelatin Co. property is described generally as follows: SE1/4 & NE1/4 & NW1/4, NW1/4, SW1/4 of Section 26, T.45N-R.10E. (Figure 2). The company is situated in an urban setting within the town of Grayslake. Bordering the property on the north is Central Park, on the east is a former farmstead (currently not in operation), on the south is a warehouse and a residential area, and on the west is the Soo Line Railroad tracks, beyond which is the Grayslake downtown area and residential areas.

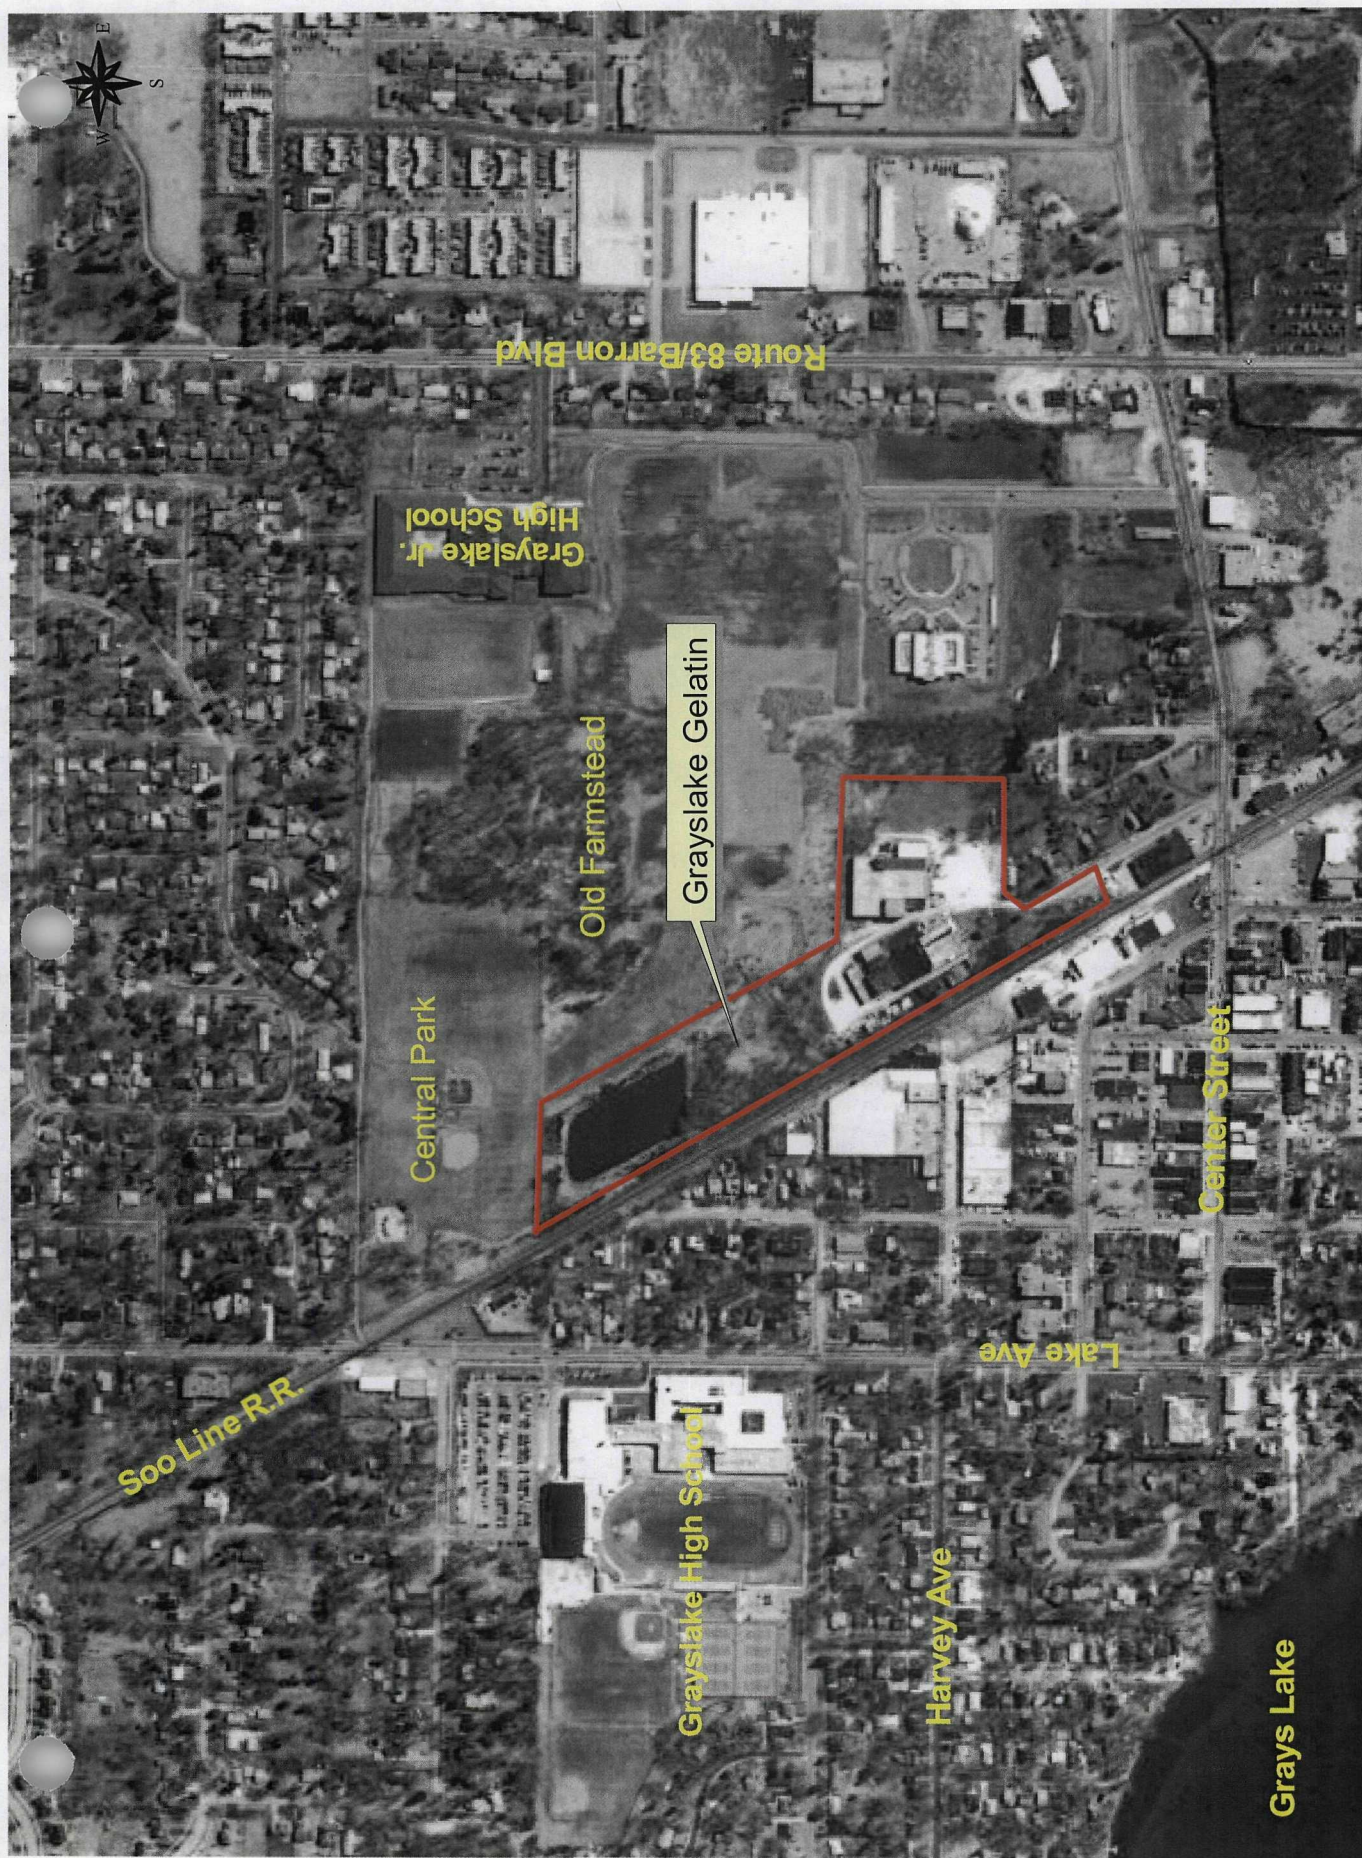
**FIGURE 3**

**SITE AREA MAP**

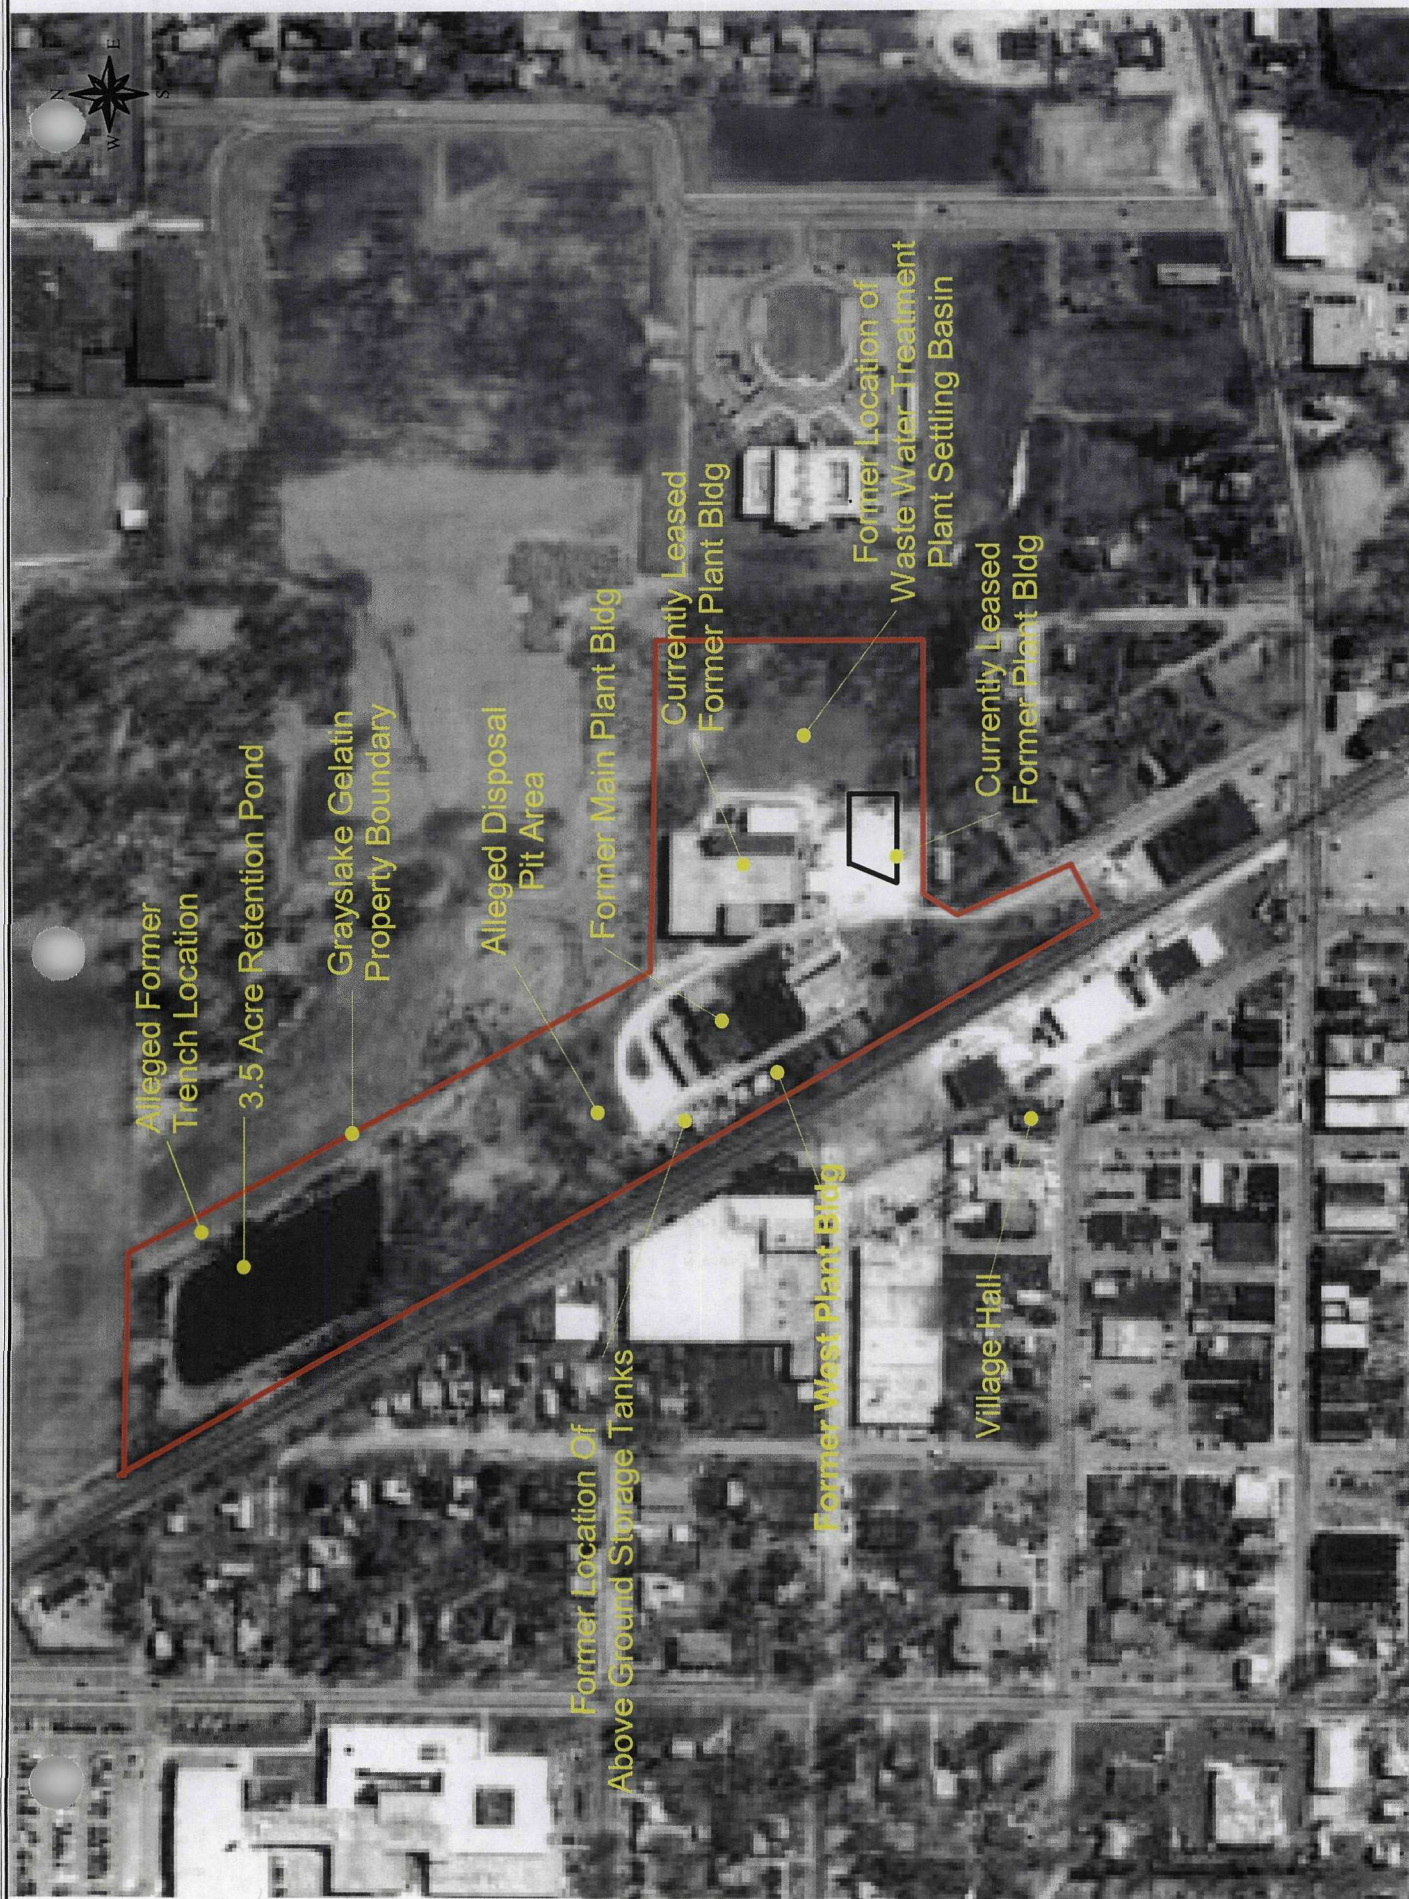
FIGURE 4

## SITE FEATURES

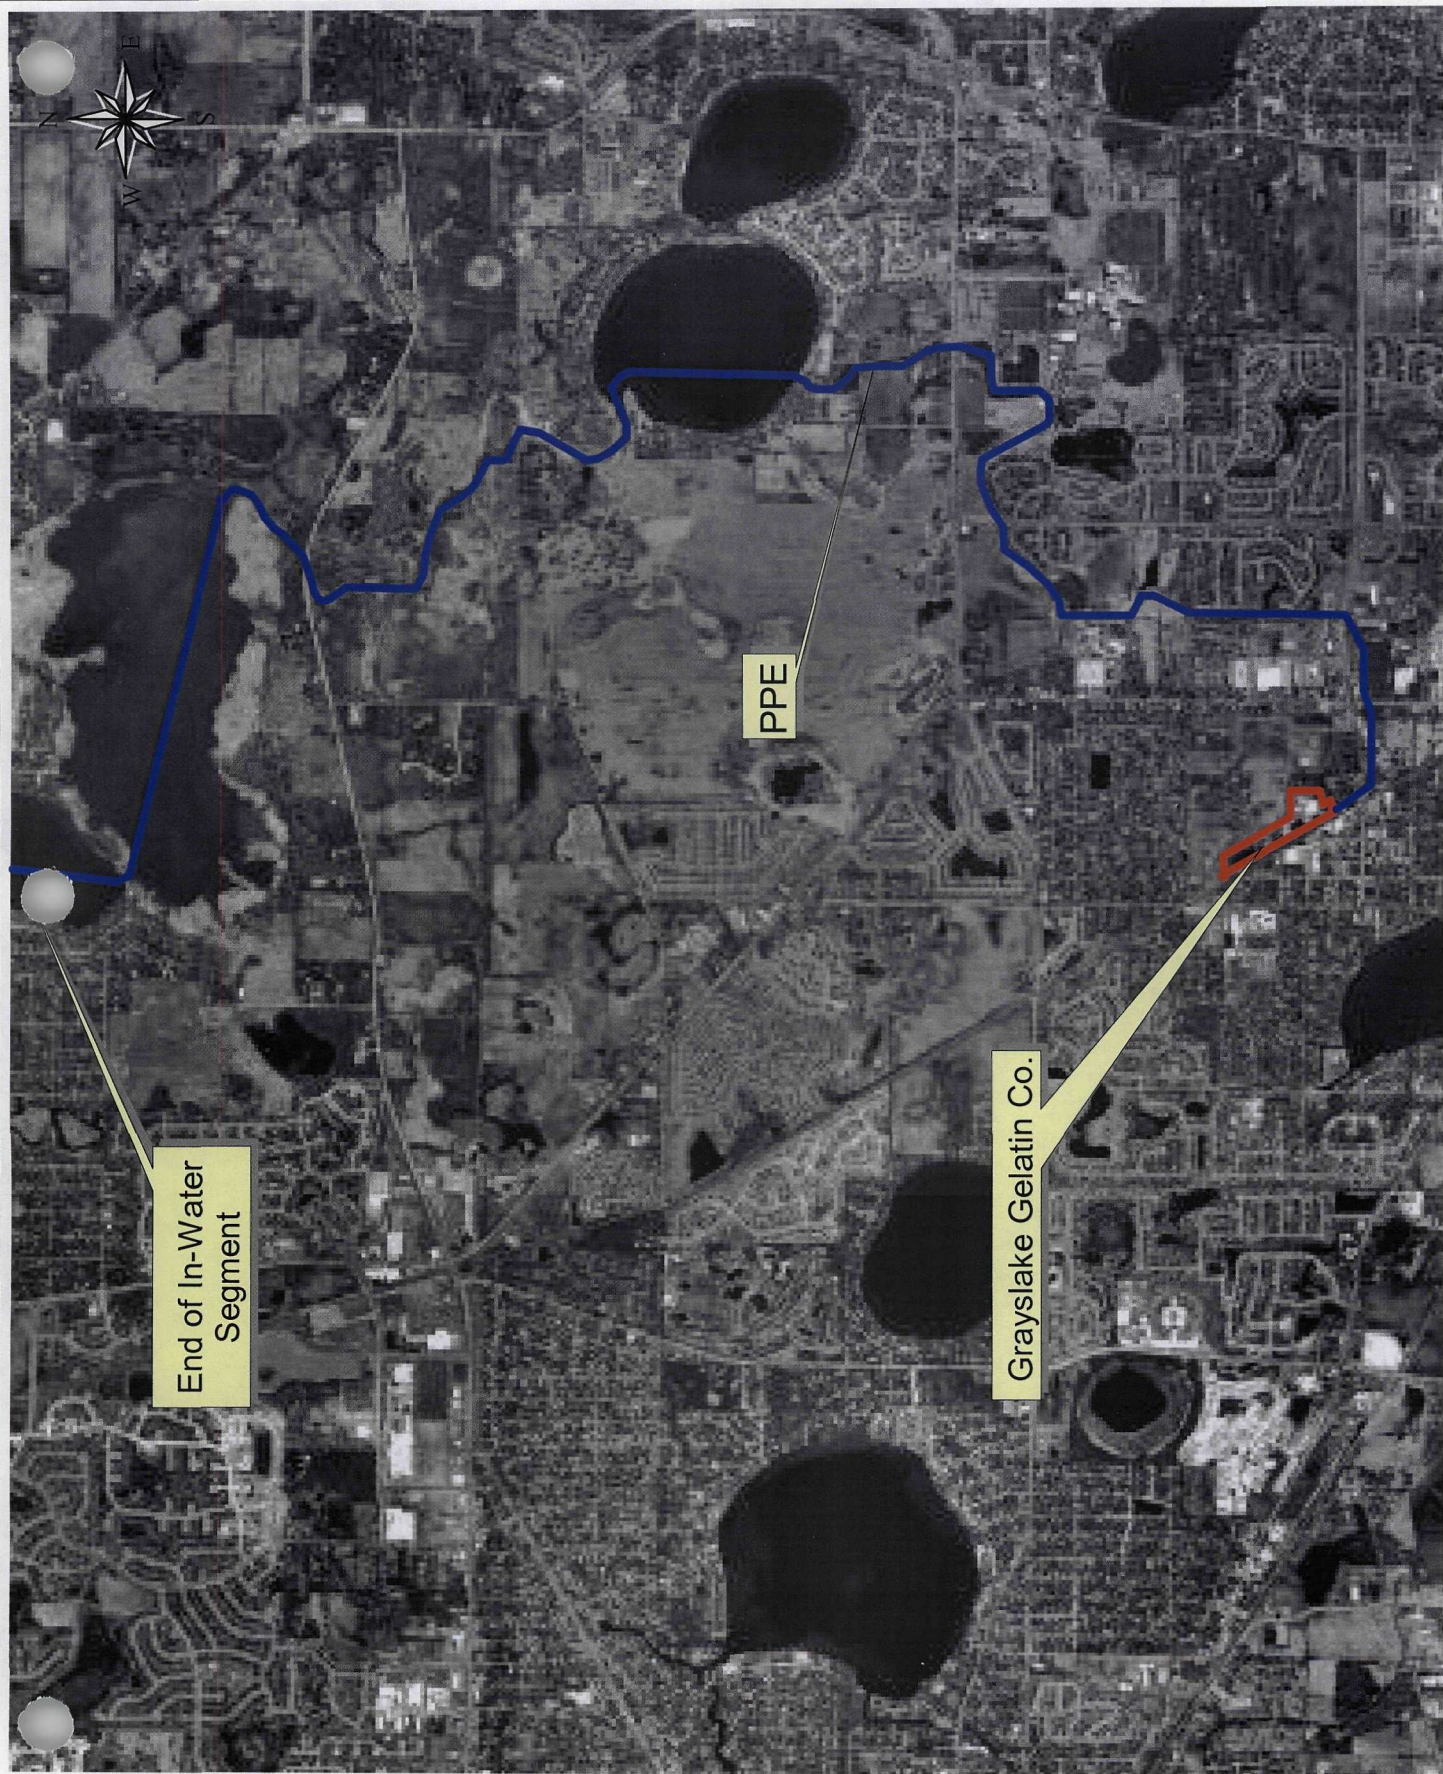
15-Mile Surface Water Route Map

The surface water runoff route (Figure 6) is vague once off site, however, the flow south can be traced to Center Street, south of the property, then east along Center Street eventually following drainage routes north approximately seven miles and terminating in Miltmore Lake. Additional details regarding the surface water runoff route can be found in Section 3.2 of this report.
